H&H Home Inspection Inc.

Royersford Apartment

Foundation walls

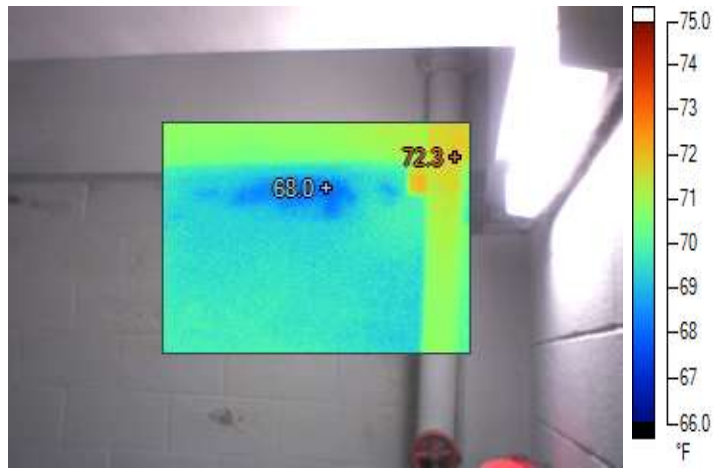
IR20061005_0141.is2

Wall area after using water hose. Emissive set at 1.0

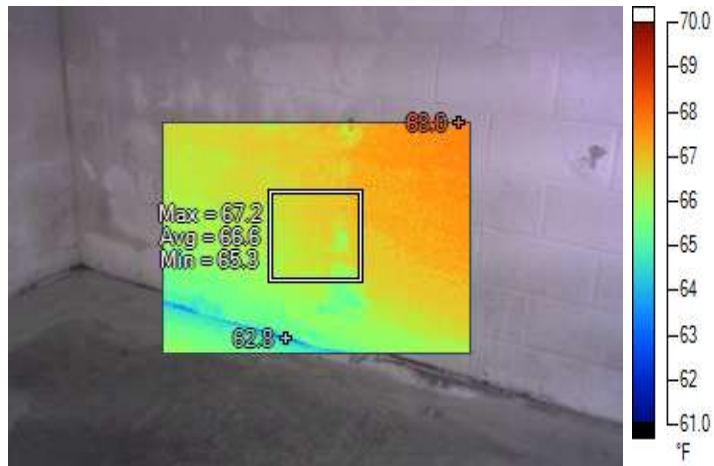
IR20061005_0147.is2

Garage wall where slab and wall meet.

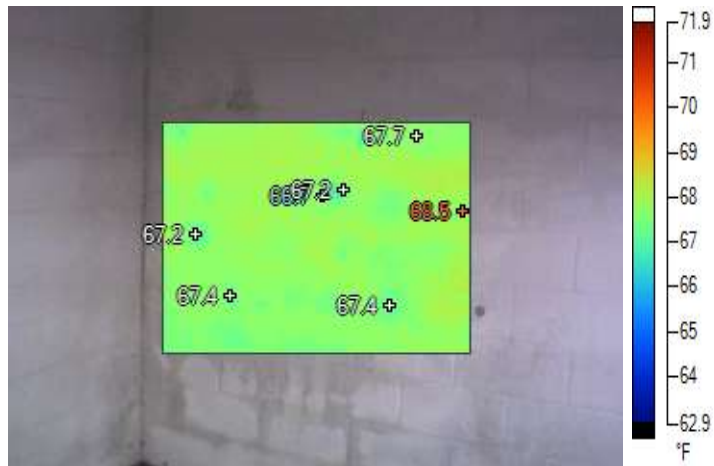
IR20061005_0148.is2

Same garage wall after using hose.

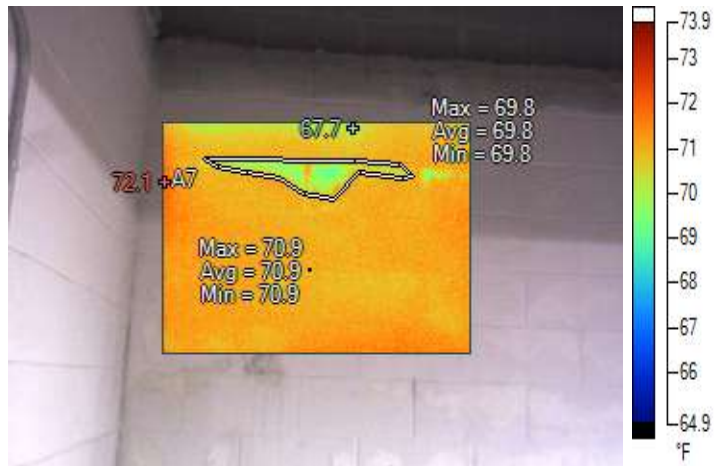
IR20061005_0149.is2

Change emissivity

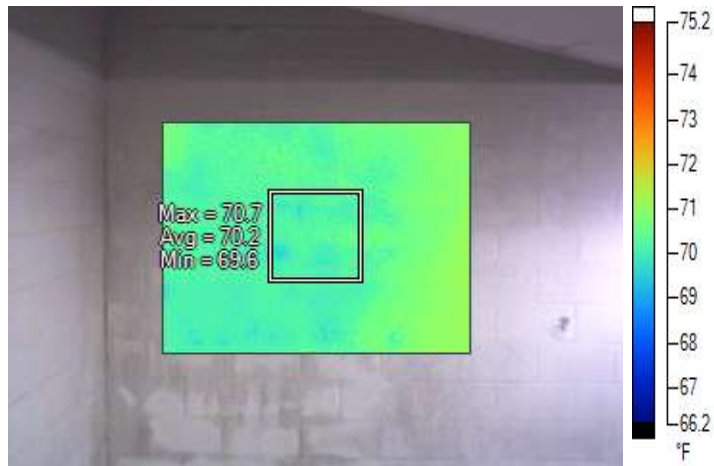
IR20061005_0150.is2

Garage wall at same corner where suspected leak.
these marks are not as active as other side of wall.

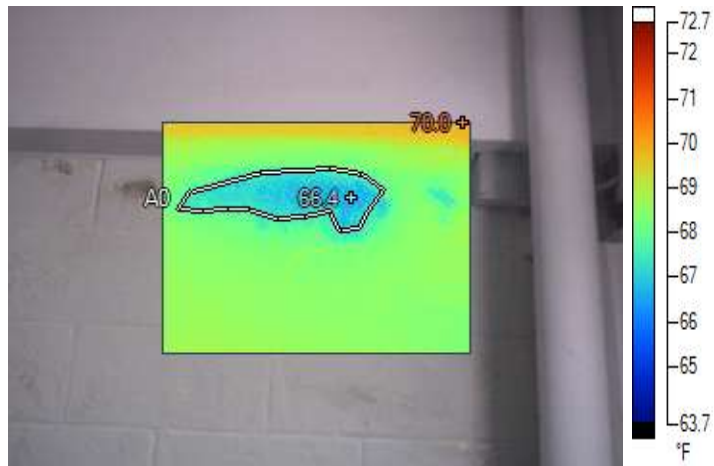
IR20061005_0152.is2

Staircase wall at exterior ground level at corner.

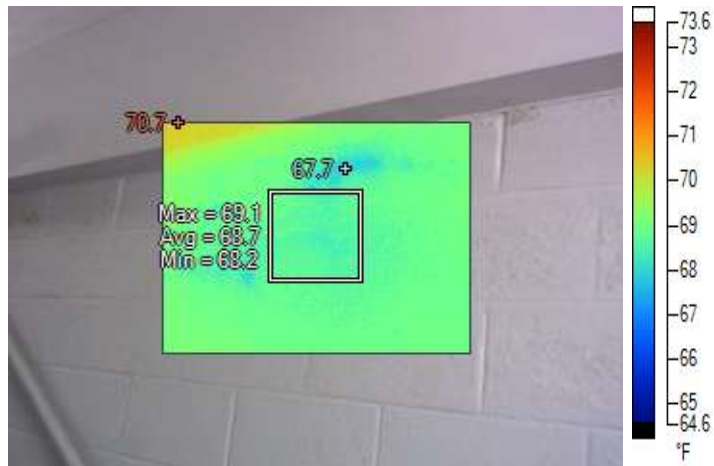
IR20061005_0153.is2

This area is at exterior ground level.

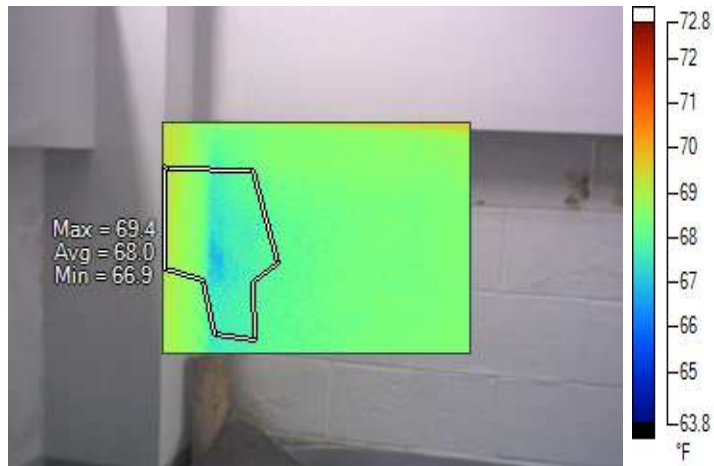
IR20061005_0154.is2

The problem seems to be from the exterior waterproofing.

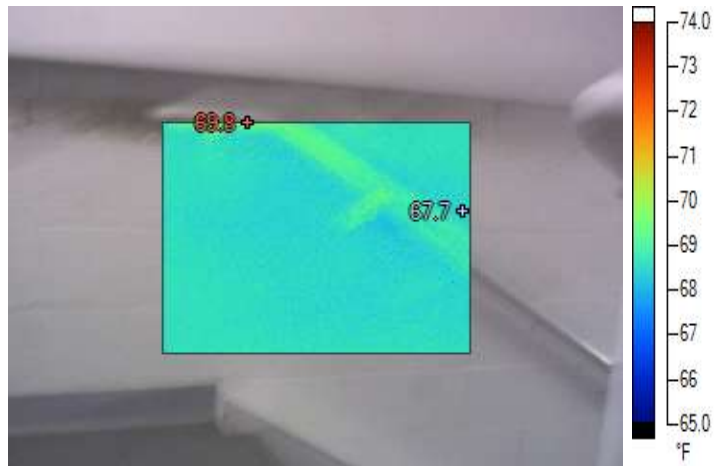
IR20061005_0155.is2

Slight moisture after using water on wall. This was done for a short period only. Emissivity was 1.0
